WILTON
1425 Twiggs Ferry Road
Hartfield, VA 23071

Treatment Report:
Conservation and Selective Painting of Interior Finishes

Prepared by: Christopher Mills, Christopher Mills Conservation Services, LLC

December 27, 2013

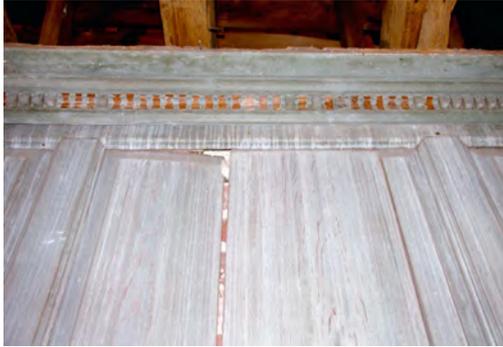
the panels exhibited white drip marks or lime staining from water infiltrating from the ceiling edge (fig.1). The cornice was roughly 80% intact with 90 of the dentil elements missing. The source of the moisture at the north wall that was from the north side exterior masonry.⁷ The prolonged water infiltration resulted in termite infestation/damage which compromised the structural integrity of the panelled wall.⁸ The wood supports at floor level were completely compromised, causing the wall to sag at the center (roughly 2.5”) forcing the panels to shift out of place (fig.1&5). Although it was recommended that the north wall be taken down for assessment and consolidation, the decision

Fig.1 North wall with missing dentils and staining

A number of the missing dentils in the cornice were located and reattached using adhesive-strength B-72 (50% solution in xylene). Approximately 60 dentils are still missing (mostly from the north wall), exposing bare wood where they once were.

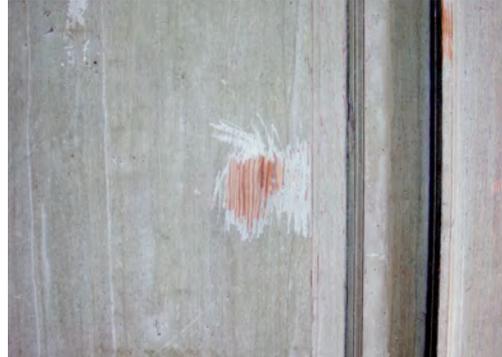
Fig.2 East wall surface damage

The areas that were scratched down to the wood -in the upper panel of the east wall just to the north of the doorway and the center vertical stile of the south wall, were inpainted with Gamblin Conservation Paints (soluble in isopropyl alcohol). Attempts to clean or remove the ink-like spatter (fig.3), located south wall center lower right panel, were unsuccessful and also inpainted with Gamblin Conservation Paints. Two areas of water staining (white streaking), above the door in the east wall and above the north closet door in the west wall, were also inpainted. All other damage and natural paint loss was left as is after stabilizing.

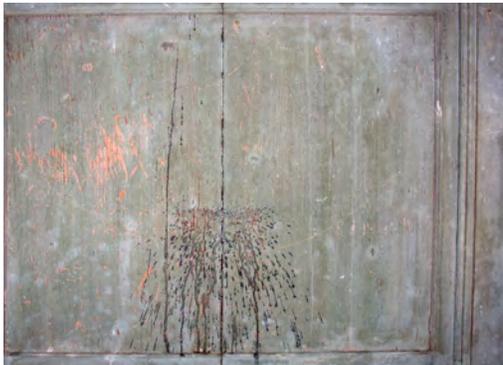
Fig.3 South wall ink spatter

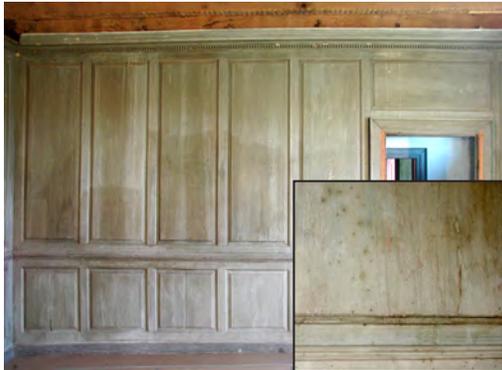
Fig.4 Paneled room, east wall staining

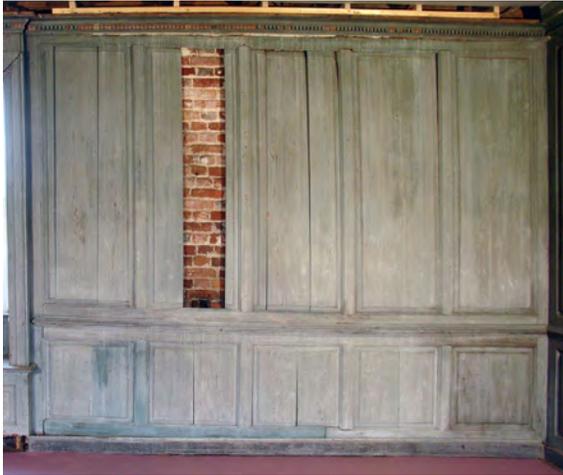
Fig.5 West wall before treatment

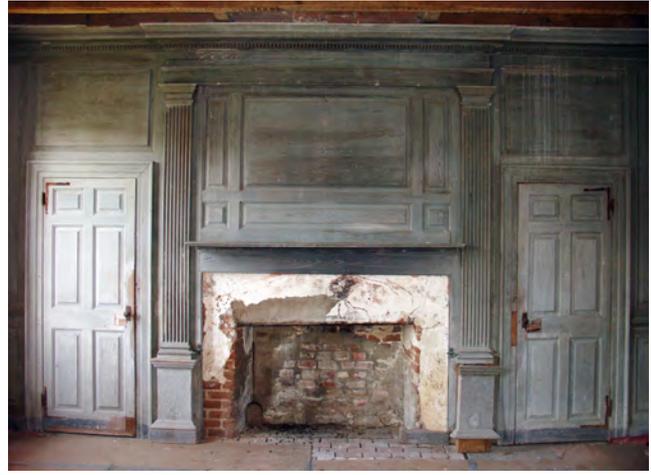
Fig.6. West wall before treatment

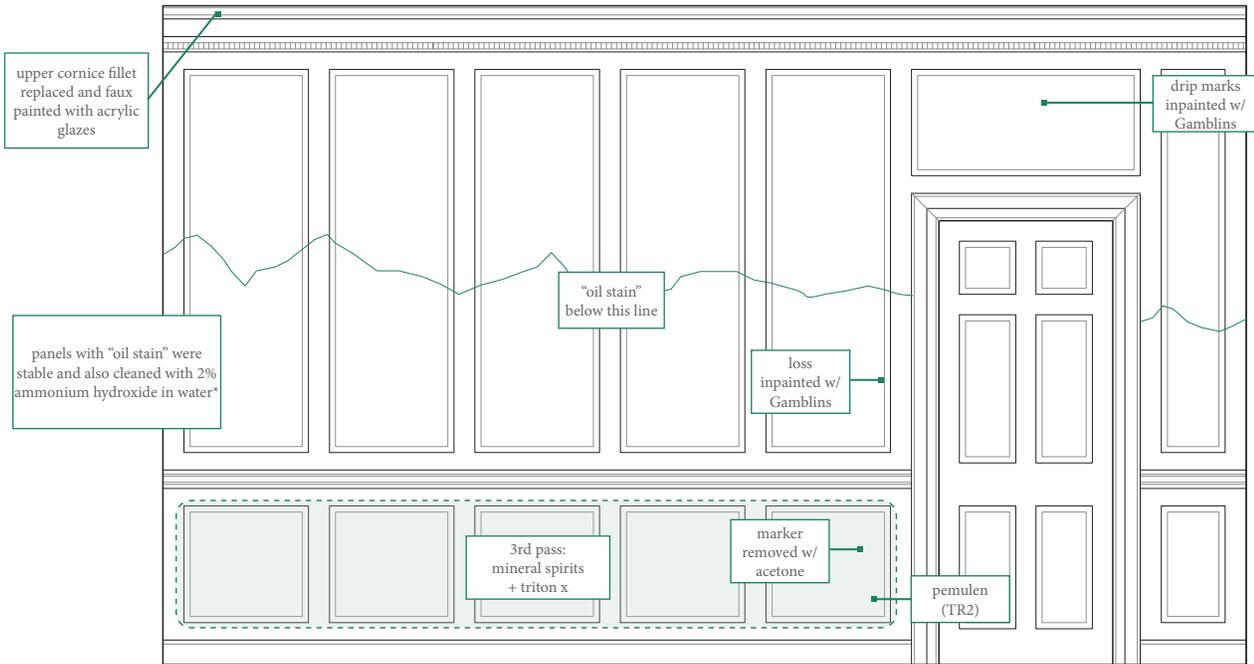
EAST WALL

*Not all of the "oil stain" was removed. Testing found that 1% Sodium Hydroxide in water was effective at removing the "oil stain", but the high pH and noted color shift deterred its use.

Entire wall vacuumed; one pass mineral spirits w/ webrils, 2nd pass mineral spirits + triton x, cleared w/ mineral spirits; selective use of acetone and ammonium hydroxide to mitigate stains. Baseboard cleaned w/ ammonium citrate and cleared w/ water

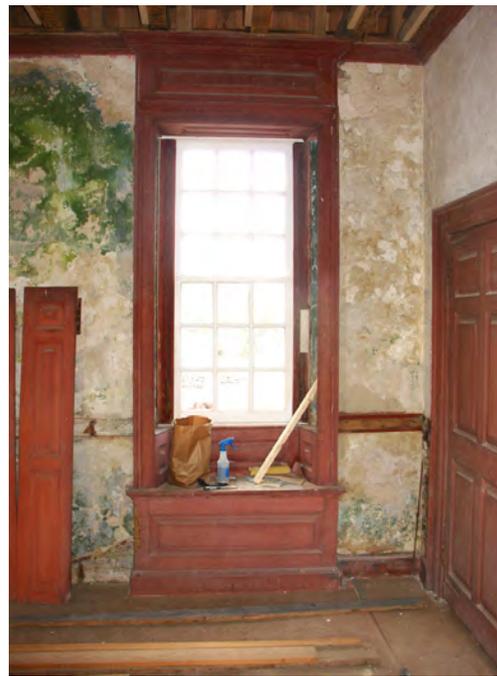
Fig.19 SE room north wall before treatment

The plaster walls exhibited significant planar distortion in the east wall, above the fireplace, and considerable problems with delaminating plaster on the north and west walls. The finishes on the plaster walls presented as a palimpsest -or inconsistent mixture of historic finishes that were predominantly light green and yellow in color. The north wall had a history of water infiltration resulting in unusual staining, deep green and yellow in color, that appeared to be absorbed into the plaster (fig.19).

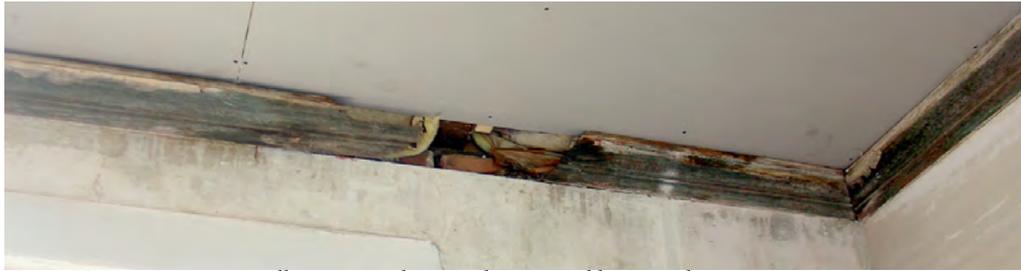
Fig.26 Center stairs west wall cornice with water damage and heavy soiling

New frames were installed around all doors and doorways, with the exception of the arched entrance to the South Passage. A Dutchman was fabricated to replace the 30” section of cornice in the west wall that was water damaged. Evidence on the door found in the cabin (currently in the SE room) indicated that the doors and doorframes in this room were painted the same blue-green as the other woodwork. All new pieces were prepped and primed, then faux-painted to match the historic trim (fig.29-30). A black baseboard line was carried through the bottom of the new doors, plinth blocks and frames. The decision to include this distinct element on the new doors was based on the historic evidence found on the entrance door and closet doors in the Southwest paneled room as well as other moldings and plinth blocks in the South Passage and Center Stairs.

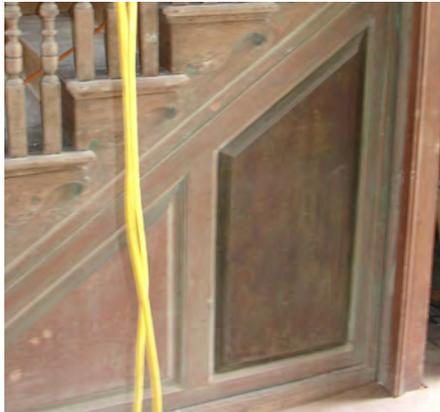
Fig.27 Stair panel before treatment

The panels on the lower stair were cleaned with cotton batting and mineral spirits. Solvent tests found that the darker brown panel had a layer of shellac applied (fig.27). This was removed with cotton batting slightly dampened with ethanol(fig.28). The shellac could not be removed completely without negatively affecting the extant historic paint layers, therefore the panel presents as slightly darker than the surrounding material (fig.29).

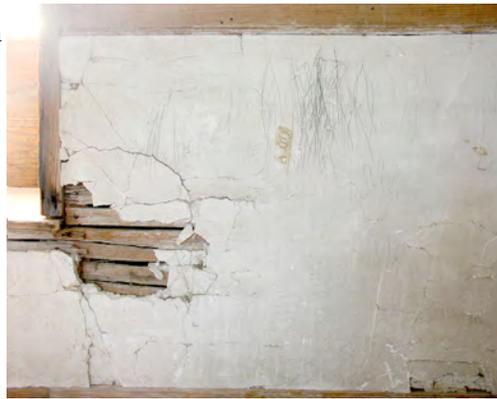
Fig.36 Easty wall conditions

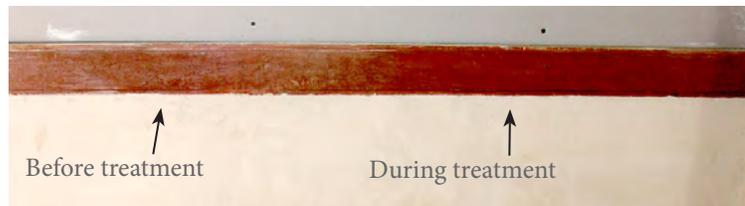
Fig.44 West wall chair rail during treatment

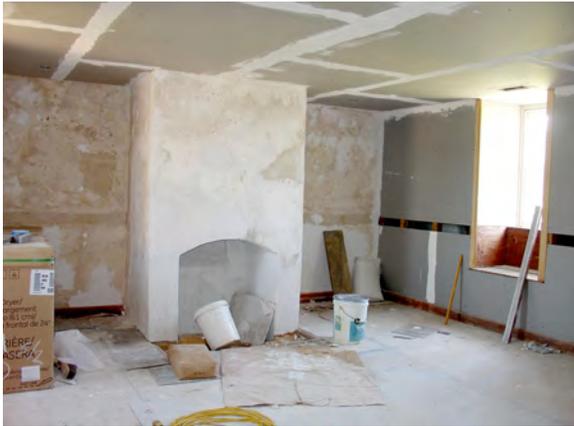
Fig. 46 Southeast Chamber/SE view before treatment

noted on the north side. The fragments of a surviving finish on the plaster appeared to be multiple layers of unpigmented (white) limewash (fig. 46). Approximately 50% of the historic woodwork was missing during the time of the assessment. The surviving woodwork included the south door and door frame, window seats, and all of the baseboard. The condition of the wood was fair with the expected checking and splintering found throughout the house. The finish was the same red-brown paint found in other second floor rooms and is the first and only paint applied to the woodwork.³⁴ The conditions of the paint varied with the most fragile finishes on the window seat surrounds and baseboards where approximately 30% had been worn away (fig.47). The paint on the baseboard appeared inconsistent and blanching and included construction related damage such as plaster residue, spatter and watermarks from the recent plaster removal. The paint on the south door was in good condition, stable to the touch, and 95% extant. Suggesting that, like the door in the Southwest Chamber, it had been open much of its life and not in contact with direct sunlight. The finish presented darker, with an inconsistent, whitish film covering the surface. The door and door frame had a buildup of hand oil grime around the knob area that presented as glossy black (fig. 48). New elements included the north door and frame, chair rail, window seat moldings, and closet doors flanking the fireplace.
