Archaeological testing for chimneys on an historic outbuilding at Wilton, Middlesex County, Virginia

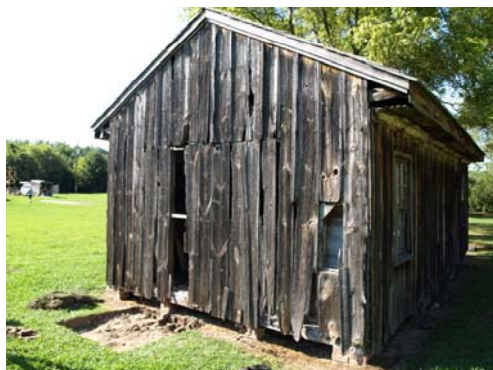
Figure 1: Frame outbuilding east of the Wilton house, looking north.. Test Units 13 and 14 were excavated on this gable.

a 5' square and a 3' by 2.5' unit were excavated adjacent to the south gable (T.U. 13 and 14) (Figure 1).

Test Units 13 and 14 tested for the presence of a chimney on the building's south gable end. They encountered a similar mix of layers as those in T.U.s 11 and 12. A notable difference between the two areas was the absence of a chimney builder's trench. Instead, the chimney appears to have been built directly on the 19th-century ground surface, or a much wider area was dug down to the necessary depth. The other significant difference was that Layer B, the chimney demolition layer, was filled with even larger quantities of mortar chunks, as well as many whole bricks and brick bats. More substantial portions of the east and west sides of the chimney were preserved in these units (Figures 4 and 5) compared to those in T.U.s 11 and 12, but the interior (north) hearth foundation was missing. A thin bed of mortar indicated the location of this missing element. The majority of the artifacts found within Layer A (topsoil) and Layer B (chimney demolition layer) appear to date to the early-to-mid-20th century. Further analysis of the artifacts may better refine these conclusions.

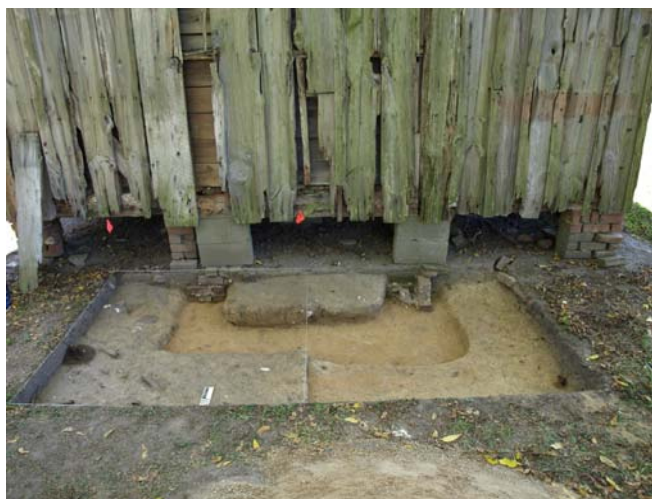
Test Units 11 and 12 were dug in several layers. Layer A, a very dark grayish brown (10YR3/2) sandy loam topsoil, covered the entire unit and was filled with a large quantity of rubbish, including numerous nails, a large number of window glass, ceramic, and bottle glass fragments, an iron tool and other hardware fragments. This layer represents the most recent activities in this part of the site, specifically trash from the building's use as a shed. Layer B was the robbed chimney foundation hole, containing very dark brown (10YR/2/2) sandy loam and mortar chunks. Smaller quantities of artifacts similar to those found in Layer A were recovered from Layer B. This robbed U-shaped chimney footer, filled with mortar but very little brick (Figures 2 and 3). The foundation of the hearth wall for the chimney was also still partially intact just south of the units' southern edge. This foundation was laid one course of

Figure 2: View of T.U. 11 and 12 following excavation of the robbed chimney trench.

brick shallower than the chimney/pier foundation on either side of it. The apparent dimension of this chimney as built were approximately 6.1' wide (E-W) by 2.7' deep (N-S) measured from the outer wall of the frame structure.

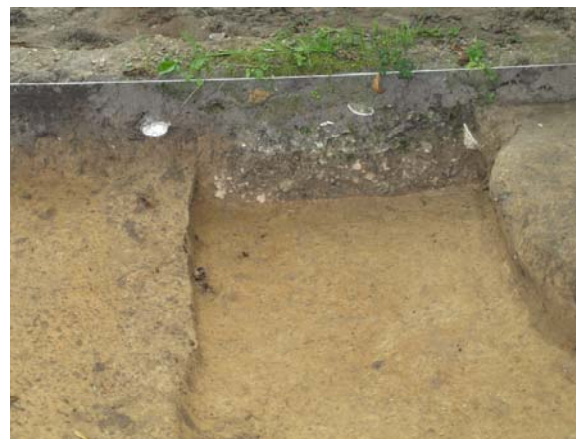
Figure 3: Detail of T.U. 11 East profile, showing the robbed chimney trench filled with mortar, with a narrow original builder's trench visible on the left side.

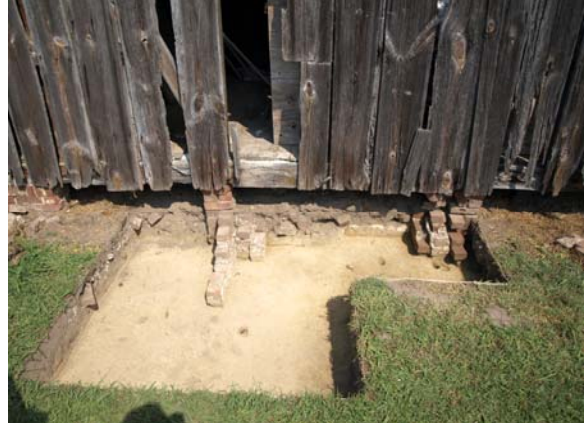
Figure 4: View of T.U. 13 (left) and 14 showing the remains of the chimney foundation.

It is our opinion that the archaeological remains of these two chimneys have been sufficiently documented to justify the rebuilding of similarly-sized chimneys in the same locations. The small portions of intact chimney foundation brick will need to be removed in order to properly build the new chimneys, as they are not substantial enough to support, or be included within, the new construction. Outside of the test units excavated there are intact layers and features that preserve an important record of the life of this building and the surrounding activity areas, and all attempts should be made to avoid any impacts to these resources.

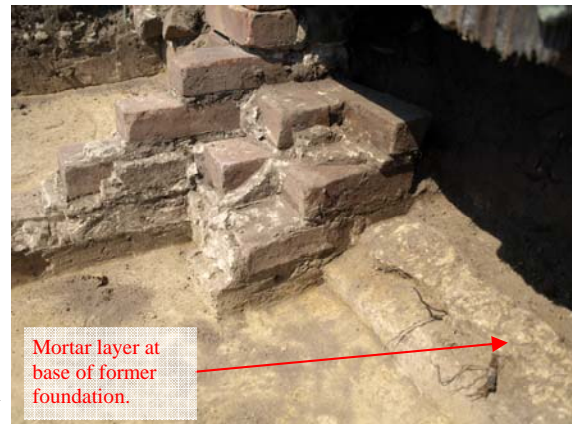
Figure 5: Detail of the western chimney remnant in T.U. 13. The majority of this element was robbed, including the interior portion of the hearth where a mortar base layer is still visible.
