FINISHES ANALYSIS REPORT

WILTON HOUSE, OUTBUILDING: INTERIOR FINISHES

AUGUST 30, 2013

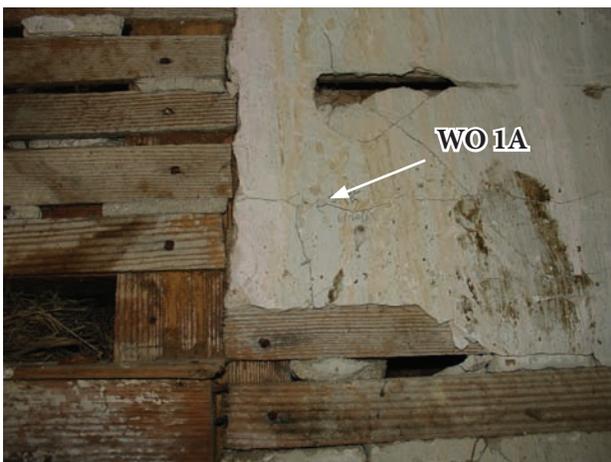
plaster and limewashes, west wall, sample location for 1A

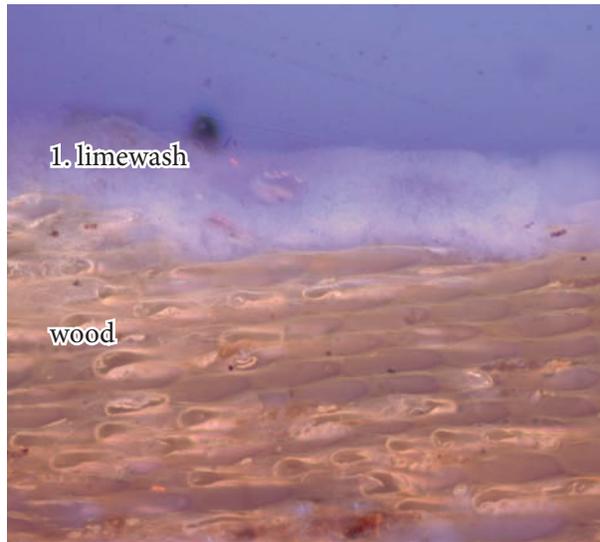
CROSS-SECTION MICROSCOPY RESULTS - WAINSCOT AND LIMEWASHES**SAMPLE WO 2A: WAINSCOT, SOUTH SIDE, NORTH WALL, RIGHT OF OPENING**

*WO 2a, visible light, 100x*

*WO 2a, UV light, 100x*

Sample WO 2a did not contain as many layers of limewash as the sample from the plaster walls, and this was confirmed through cross-section microscopy. This sample was repolished numerous times to expose the best example of extant finishes in cross-section, but only one limewash layer was eventually exposed.

This limewash does not appear to be the same as the first layer of limewash on the plaster wall (sample WO 1a), which had a pinkish-colored autofluorescence. By contrast, the limewash in the sample above has a more light purple-colored autofluorescence, like layers 2-5 on the walls. However, limewashes are usually so similar in composition that it can be impossible to clearly align layers.

The absence of limewashes in this sample most likely results from the expansion and contraction of the wood substrate, which exacerbates the flaking and loss of these naturally brittle finishes.

This sample was stained with fluorochromes to determine if organic media was present (see pages 8-9). The reaction for carbohydrates (TTC) was negative. Strong positive reactions for proteins (FITC) and lipids (DCF) were observed in all layers, suggesting that some type of proteinaceous or oil-based components were added to the limewashes to enhance their durability and working properties.

Only one layer of limewash was found on the wood panelling. It was unclear how this limewash aligned with the walls. It seems likely that this sample is also missing the complete finish history. Fluorochrome staining determined that this limewash contained both proteinaceous and oil-based additives. Again, this would need to be confirmed with FTIR or GC-MS.

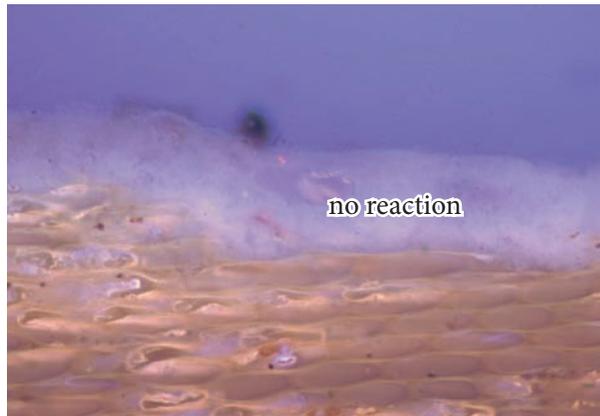
WO 2a, UV light, 100x. Before TTC stain.

WO 2a, UV light, 100x. TTC reaction.

Sample WO 2a was stained with TTC to detect carbohydrates in the stratigraphy. No reactions (a reddish-brown color), were observed.
